**Bat Survey:** Former Palace Cinema and Rhymes Day Nursery, Bedwlwyn Road,  
Ystrad Mynach

**Instructed by:** Wales and West Housing

**Reported by:** Ecological Services Ltd  
10 Mount Pleasant, Llanelly Hill, Abergavenny, Monmouthshire, NP7 0NT

Author	Date	Version
Richard Watkins	November 2025	V2.0

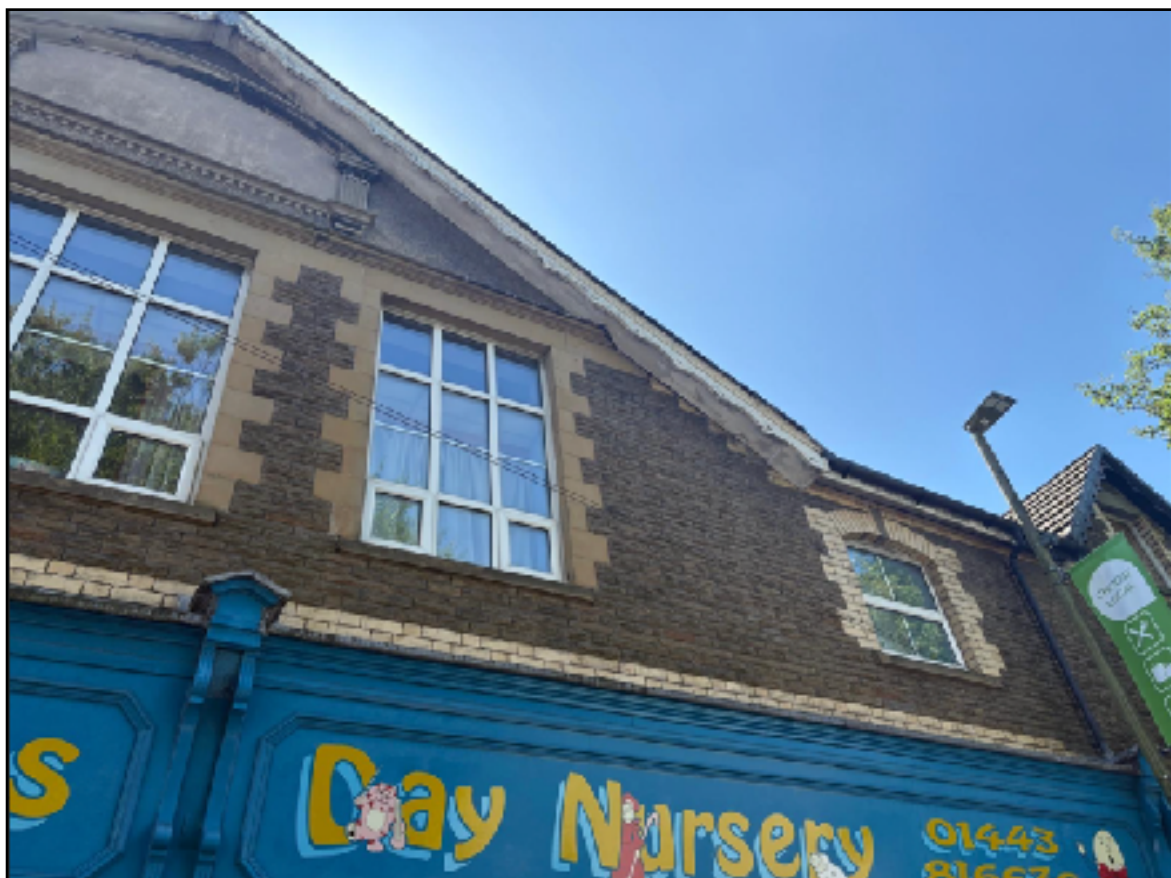
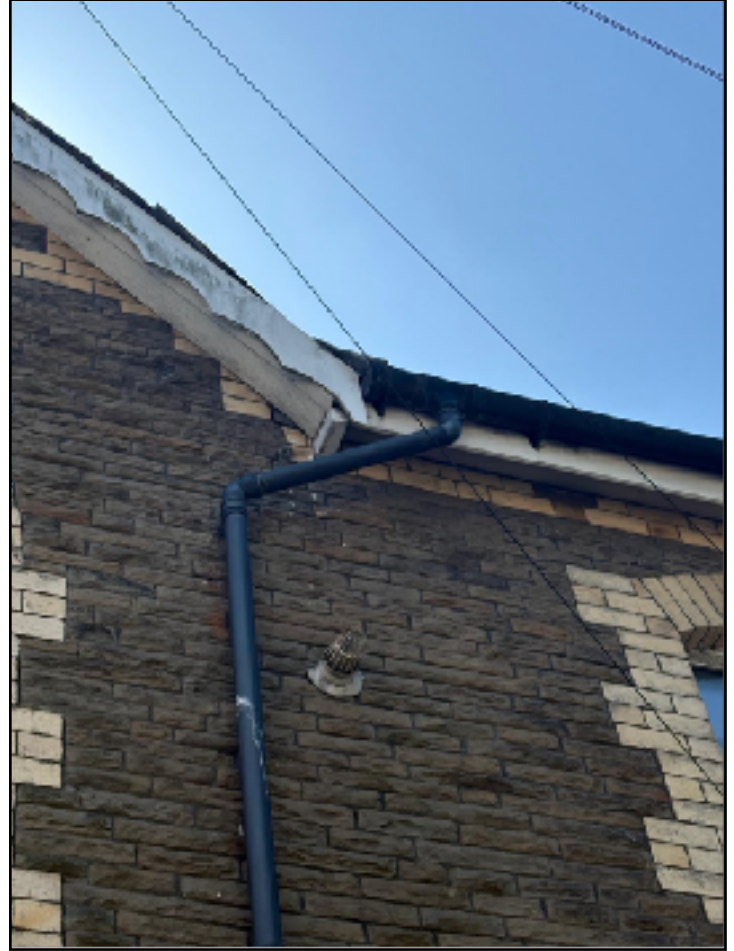
**6.3** Due to the age and condition of the building, there were a small number of opportunities present for bats to access and use the building and those that were available were deemed as having moderate potential for roosting bats. There were raised slates and ridge tiles; areas of raised lead flashing and apertures between the soffits and the walls.

**6.6** Examples of apertures allowing access to cavities in the building:

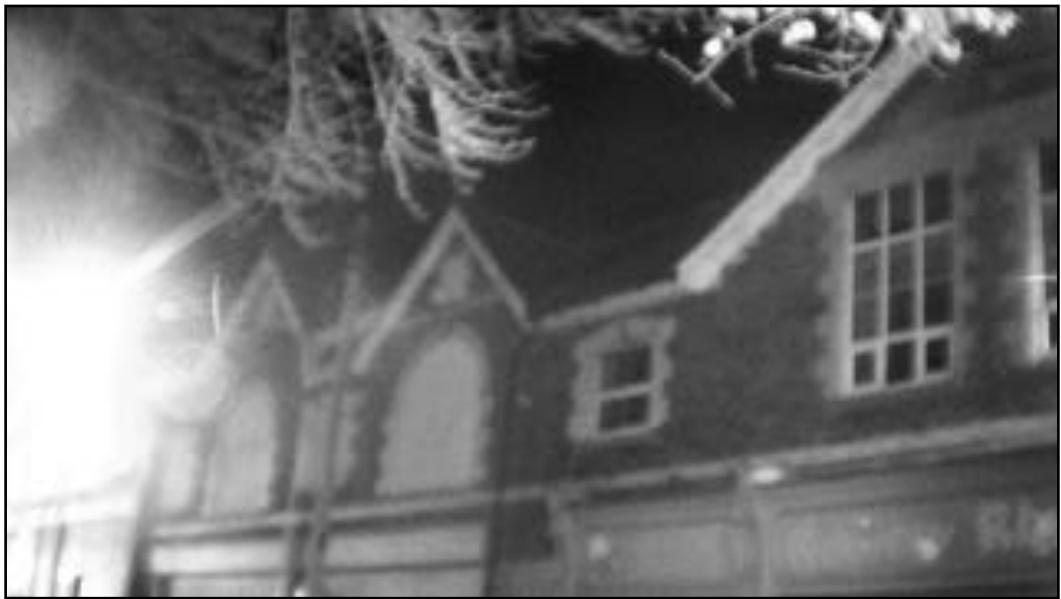
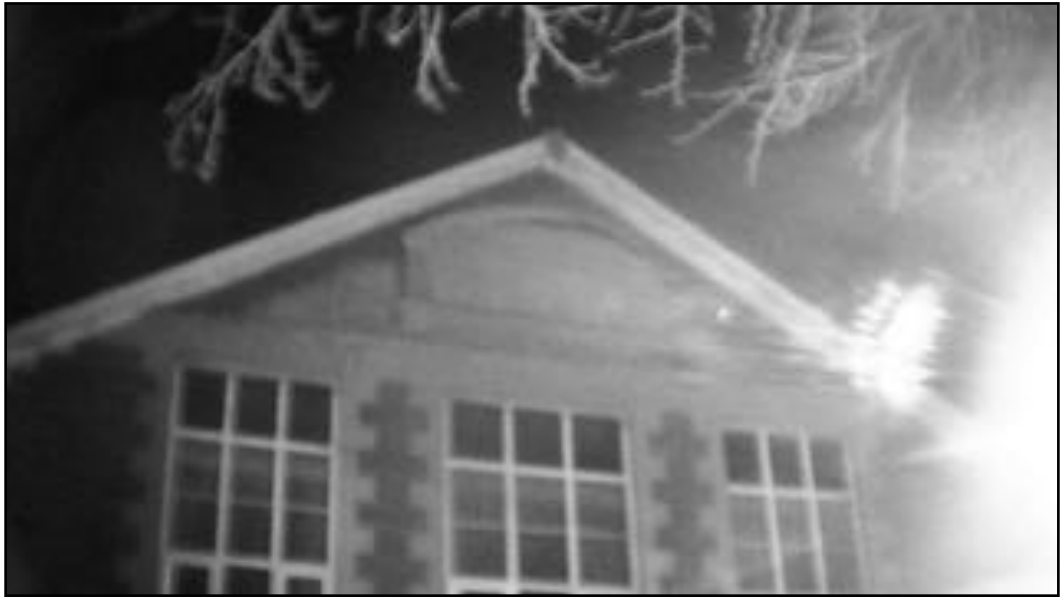
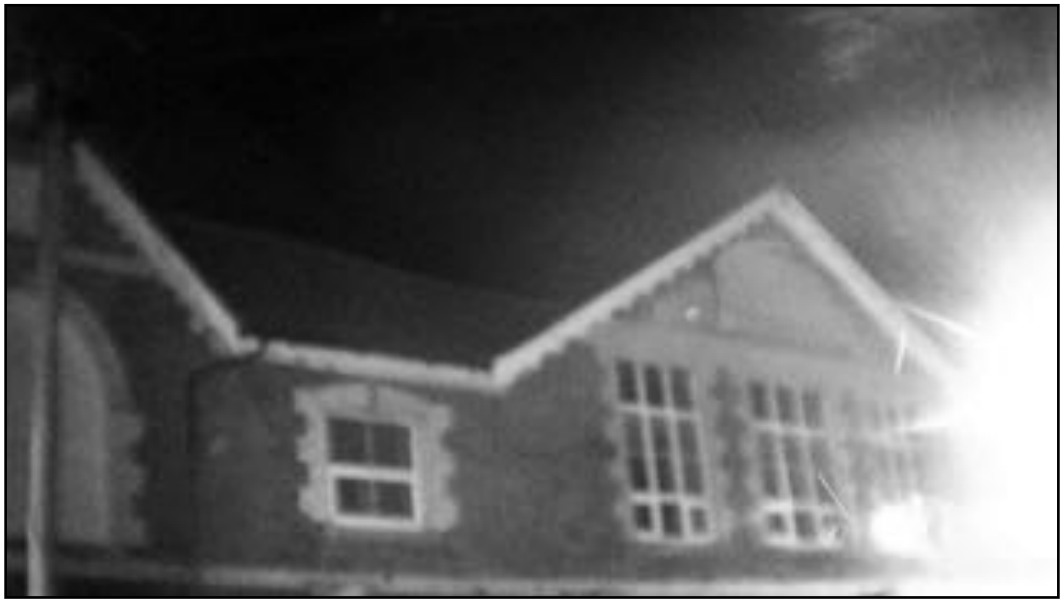
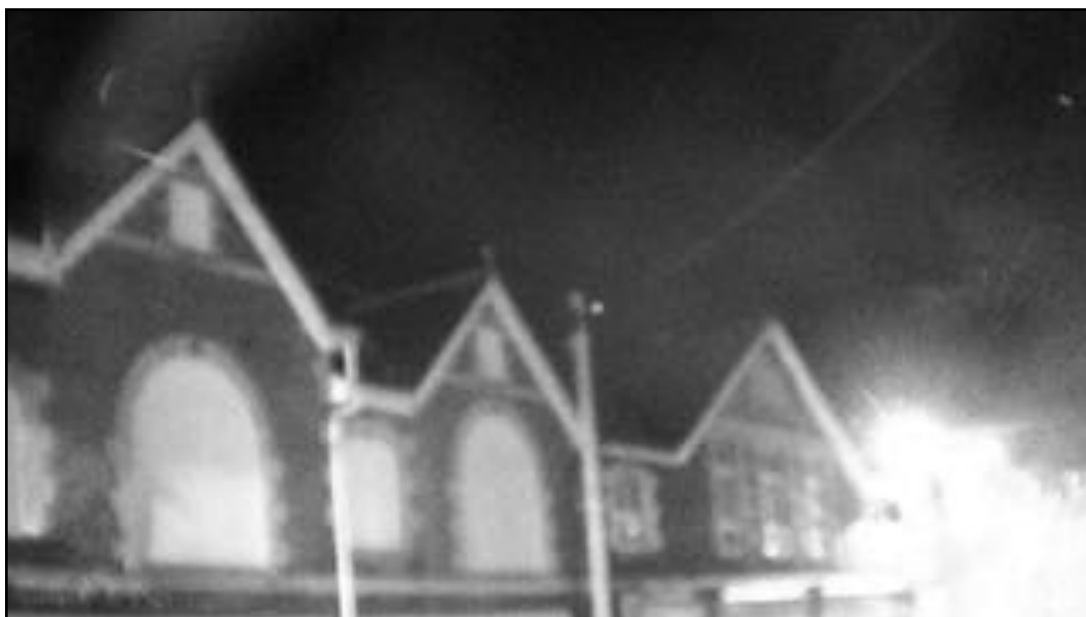
8.11 Examples of NVA Still Shots:

**9.1 During the emergence surveys, no bats were observed emerging from the building.**

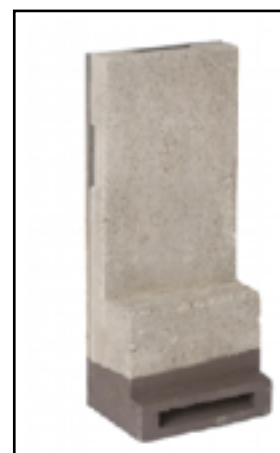
**10.2** It is proposed that new roosting for bats be created by building two Vivara Pro WoodStone Bat Boxes into the block work of the new builds; one on the south eastern elevation of Block 1 and one on the south eastern elevation of Block 2. **Care must be taken not to obstruct the access slots.**

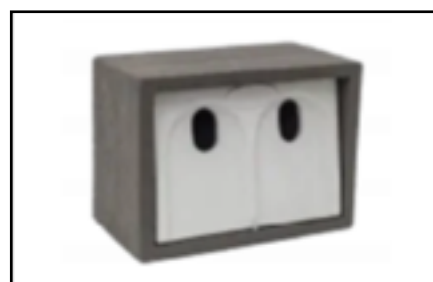
**10.4** Two Vivara Pro WoodStone House Sparrow Nest Boxes will be built into the block work of the new builds; one on the north eastern elevation of Block 1 and one on the north eastern elevation of Block 2. **These will not be situated on a south facing elevation. Care must be taken not to obstruct the entrance holes.**

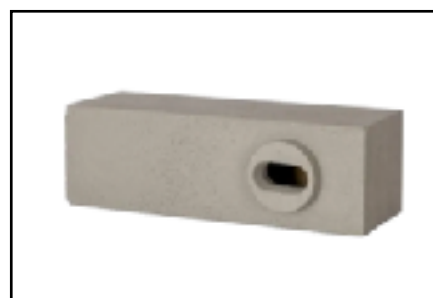
**10.5** Two PRO-UK Rendered Build-In Swift Boxes will be built into the block work of the new builds; one on the north eastern elevation of Block 1 and one on the north eastern elevation of Block 2. **These will not be situated on a south facing elevation. Care must be taken not to obstruct the entrance holes.**

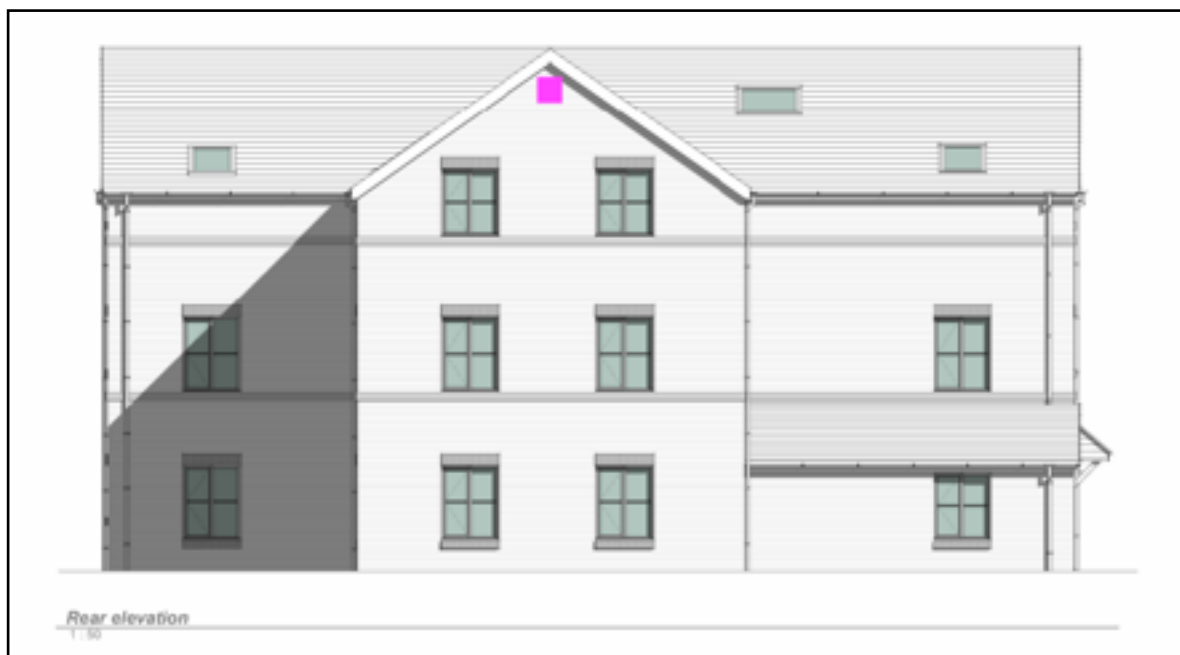
Blocks 1 and 2 - South Eastern Elevation

**10.10 Recommended Locations of Bat and Bird Enhancements:**
